# Landfill stability

## Risks and challenges

**In 2000 a dumpsite in the Philippines failed and caused a major landslide, killing more than 200 people with hundreds more missing. An understanding of waste mechanics is crucial in identifying potentially unstable landfills and can prevent future disasters.**

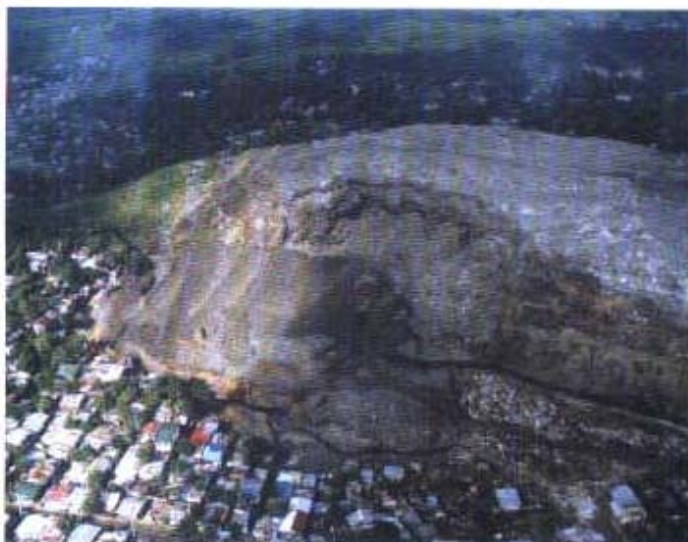
ABOVE A landfill failure in Payatas, the Philippines, killed more than 200 people. Waste and debris completely covered an area of around 30,000 m<sup>2</sup> in front of the toe of the slope. BELOW The collapsed slope of the Payatas landslide four weeks after the event. **FACING PAGE** Landfill failure in Athens, Greece. In this landslide, about 800,000 m<sup>3</sup> of waste moved, leaving a 300- to 400-metre-wide gap in the slope behind.

10 July around 5 a.m., a slope of the landfill failed and 1.2 million m<sup>3</sup> of waste slid down. This 'garvalanche' buried the scavengers' cottages and part of the Payatas B settlement area under 10 metres of waste. An area of around 30,000 m<sup>2</sup> in front of the toe of the slope was completely covered by waste and debris. Rescue actions were hindered by landfill gas, which created several fires. More than 220 people were found dead in the covered area. Rescue efforts were suspended four weeks after the landslide. There was no more hope to find survivors, and an estimated 200–800 people are still missing. The area was levelled and secured only by simple measures (peripheral trench, block lines).

The major reason for the landslide was the low waste density resulting from the composition of waste delivered to the Payatas dumpsite. The waste material was characterized by a high proportion of plastics and organics and a total absence of other materials (paper, glass, metals). MSW with this composition is resistant to conventional compaction methods, even using heavy equipment. The waste composition in Manila is typical for urban areas in developing countries and countries with emerging economies. Basically, this results from an extraordinary consumption of plastics as packaging material, a lack of recycling systems for organic waste and an outstandingly high recycling rate for reusable materials. The high recycling rate primarily reflects the country's poverty, which forces people to earn their living by segregating waste at dumpsites. The impact of low waste density on landfill stability was amplified by heavy rainfall, which is characteristic for the tropical location. The low waste density reduced the surface flow of rainwater and evaporation, resulting in a high rate of water infiltration. Landfill leachate decreased the shear strength of waste by mobilizing pore water pressure and flow pressure, finally triggering the failure. The settling of waste, due to the high content of organic materials, was also driving this effect.

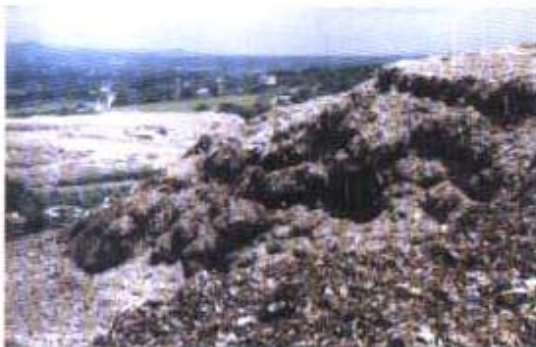
In March 2003 the eastern slope of the landfill failed and cracked down, covering the 20-metre-deep notch between the slope and the recycling facilities with waste. Approximately 800,000 m<sup>3</sup> of waste moved, leaving a 300- to 400-metre-wide gap in the slope behind.

not available yet. Water is very likely to be a cause as it is in all cases of landfill failure, but no significant water outlet from the failing slope has been reported by the operator. This point makes the case even more interesting, since landfills in arid and semi-arid areas have not been endangered unless the internal water balance is massively disturbed. Since the landfill has been constructed according to current European standards with liner and drainage systems, there was no reason to expect waterborne stability problems. It hasn't become finally clear why the slope failed. It may also be a consequence of a fire, which occurred two weeks before in the landfill stretch concerned. Landfill fires are extremely dangerous for stability: smouldering fires, which do not burn with open flames on the surface, are especially dangerous. A smouldering fire may feed its way to deeper waste layers, leaving plastics and paper burnt and sweeping their reinforcement effect away. Fighting smouldering fires with water may even double the problem, because the fire is pushed forwards while the water level inside the landfill may increase.

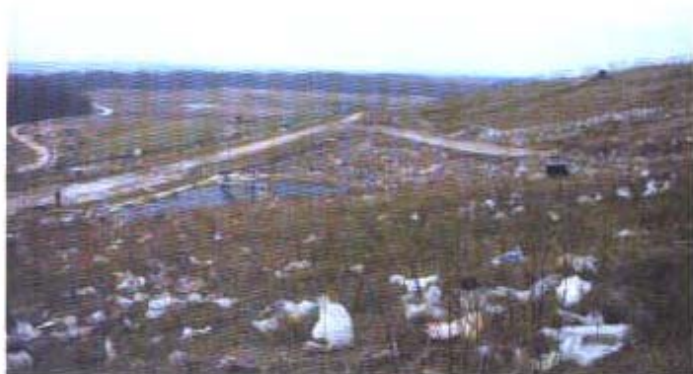
The eastern slope of the Ihlenberg landfill, where the cessation of waste dumping had caused a depression in the landfill's geometry

As required by German technical regulations, stability analysis has been conducted once a year.<sup>1</sup> In 2001, the stability calculations for the eastern slope resulted in a factor of safety of  $\eta = 1.21$ , which is significantly less than the value required by law ( $\eta = 1.30$ ). The authority, the Mecklenburg-Vorpommern agency for Environment and Mining, ordered the closure of the landfill area concerned. As a result, 400,000 m<sup>3</sup> of potential landfill volume was lost. The cessation of waste dumping had caused a depression in the landfill's geometry in the eastern slope.

Although the existing slope angle of 1:3.3 is not extraordinarily high, the slope stability seemed to be endangered. Two major factors reduced the calculated stability: some gas extraction wells showed water tables at a level of 80 mNN with the landfill base at 60 mNN. This was unfavourably considered as an uninterrupted water level above the landfill liner, although it could just have been a 'floating layer' of water. Therefore, the water pressure at the most unfavourable point of the landfill base amounted to a 20-metre water column, equal to 200 kPa water pressure. Meanwhile, the strength of waste was calculated by literature values with an angle of friction  $\varphi = 25^\circ$  and a cohesion of 10 kPa. The classic polygon sliding method (according to German DIN 4084) was chosen as the calculation method.

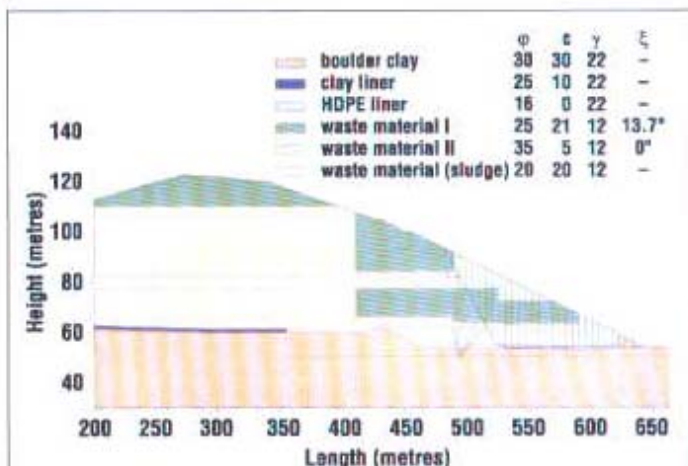
Stability analyses have been carried out using the testing results from the laboratory. Parameters for hundreds of hypothetical slip bodies in three different landfill cross-sections have been calculated. Figure 1 shows one of the cross-sections in the eastern slope and the calculation results for the sliding part found to be the most unfavourable, slip body 11. This polygonal sliding body begins at the toe of the slope, follows the mineral liner 130 metres into the landfill before crossing up to the waste. The vertical lines indicate the slices, while the amount of activated fibrous cohesion – displaying the distribution of back-holding forces around the slip body – is indicated by the slanted lines below the vertical slices.

The calculation showed that the overall stability of the eastern slope amounts to  $\eta = 1.44$  just by considering the reinforcement effect, instead of  $\eta = 1.21$  according to the previous calculation based on soil mechanics theories.

**FIGURE 1.** Stability analysis of the Ihlenberg landfill. Slip body 11, indicated by vertical lines, is found to be potentially the most unfavourable part; the slanted lines with the lighter shade indicate the distribution of activated fibrous cohesion. Material I consists of soil and some fibres; material II, degraded MSW. Slip body parameters:  $\phi$  = angle of friction;  $c$  = cohesion (kPa);  $\gamma$  = weight (kN/m<sup>3</sup>);  $\xi$  = tensile angle. A safety factor  $\eta = 1.44$  has been calculated for this slip body, fulfilling the legal requirements of  $\eta = 1.30$

Therefore, in November 2003, the authorities reopened the closed landfill area.

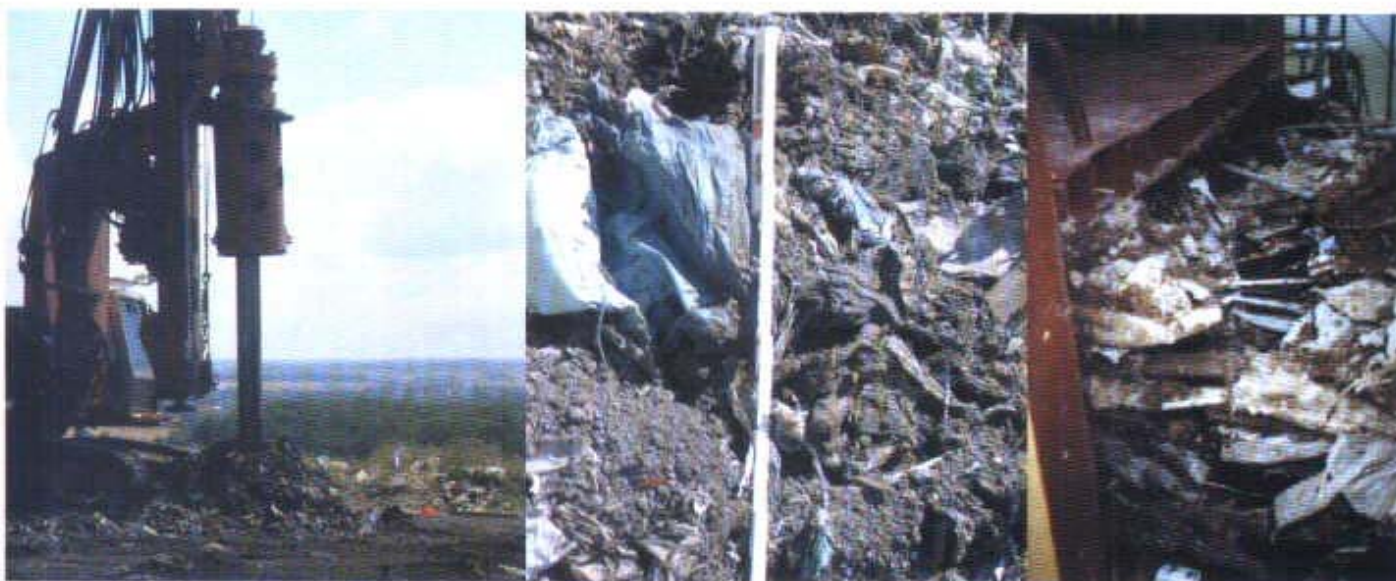
sample was drilled out of the landfill and carried to the testing facility at Technical University Braunschweig. A tension test under normal load was carried out. In this test a specific material value  $\xi$ , the internal angle of tensile stress, is determined. The sample from Ihlenberg showed an angle  $\xi = 14^\circ$  and a cohesion of 21 kPa, which is typical for decomposed or 'old' waste, while 'fresh' MSW usually comes out with  $\xi = 35^\circ$ . Under 30 metres of waste deposit (normal load 360 kN/m<sup>2</sup>), the reinforcement effect generates a total cohesion of 111 kPa, resulting from 90 kPa fibrous cohesion ( $360 \times \tan 14^\circ$ ) and 21 kPa cohesion.

ABOVE LEFT AND CENTRE A sample being drilled at the Ihlenberg landfill for examination of waste composition and laboratory testing. ABOVE RIGHT The drilled sample undergoes a tension test under normal load, in which the internal angle of tensile stress, a material-specific value, is determined
