STABILITY OF LANDFILLS – THE BANDUNG DUMPSITE DESASTER

SUMMARY: In February 2005 Leuwigajah dumpsite in Bandung (Indonesia) collapsed. 2,7 million cubic meter waste went down like an avalanche. 147 people died when the waste hit a settlement close by. The stability analysis proved that water pressure in the subsoil and a severe damage of reinforcement triggered the failure. The reinforcement was destroyed due to a smouldering landfill fire which burned over months combusting waste particles like plastic fibres and foils. The analysis proved clearly, that a realistic stability calculation is essential to recognize the stability problems correctly and to identify the appropriate response. In this case, drainage measures for the subsoil and a collection of surface run-off, as well as a consequent fire fighting could have saved the lives.

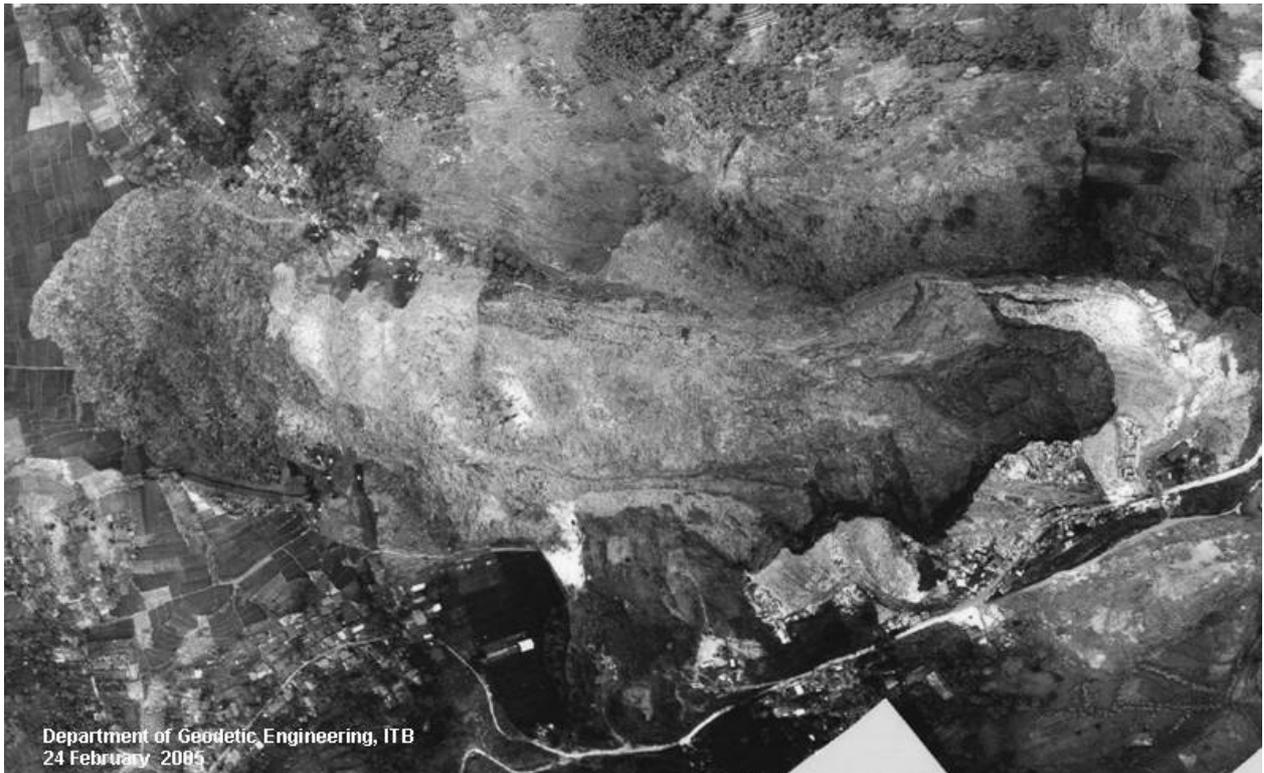
The death toll was high. Down the valley one small settlement was destroyed by half (see figure 1, close to upper left corner), another village faced light damages. Rescue teams uncovered 147 dead bodies out of the waste. Rescue activities have been carried out only in the area close to the two settlements. It is not clear, whether there were people staying overnight on top of the dumpsite, which probably were killed in other areas.

Figure 1 shows a satellite image generated by the Department of Geodetic of the Bandung Institute of Technology (ITB). The winding line in the right side of the image, which splits the dark and the light area, indicates the edge of the remaining slope. The former borderline of the dumpsite can be imagined by a straight line starting on the lower end of the existing slope. The centre part of the image shows the valley now covered by waste. Following the waste far to the left, surrounding untouched rice fields can be seen. The image indicates that the area now covered by waste have 4-5 times the size of the area where the waste originally was placed.

Figure 1: Satellite images of Leuwigajah dumpsite (taken by Bandung Institute of Technology)

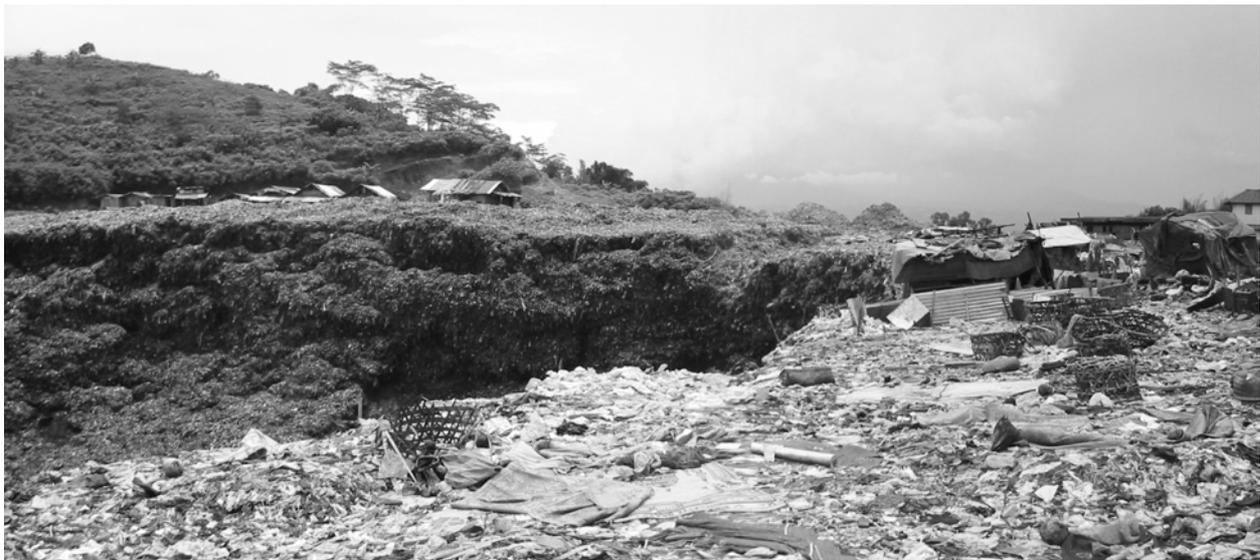
The quest, what weakened the waste strength to allow a shear failure, could be revealed. Figure 2 shows the crest of the remaining slope. It is curious to see, that the huts, where scavengers stayed during the day or lived overnight, cluster in some areas while others are free from any civil constructions. The experts suspected that smoke and smell from smouldering landfill fires may have expelled the scavengers from certain areas. Operator's staff confirmed that the landfill was burning regularly and for months. Though there was no access to the lower part of the waste cliff, some areas of the open vertical slope looked burned.

Figure 2: Slope crest with civil constructions clustering on the right and in the back

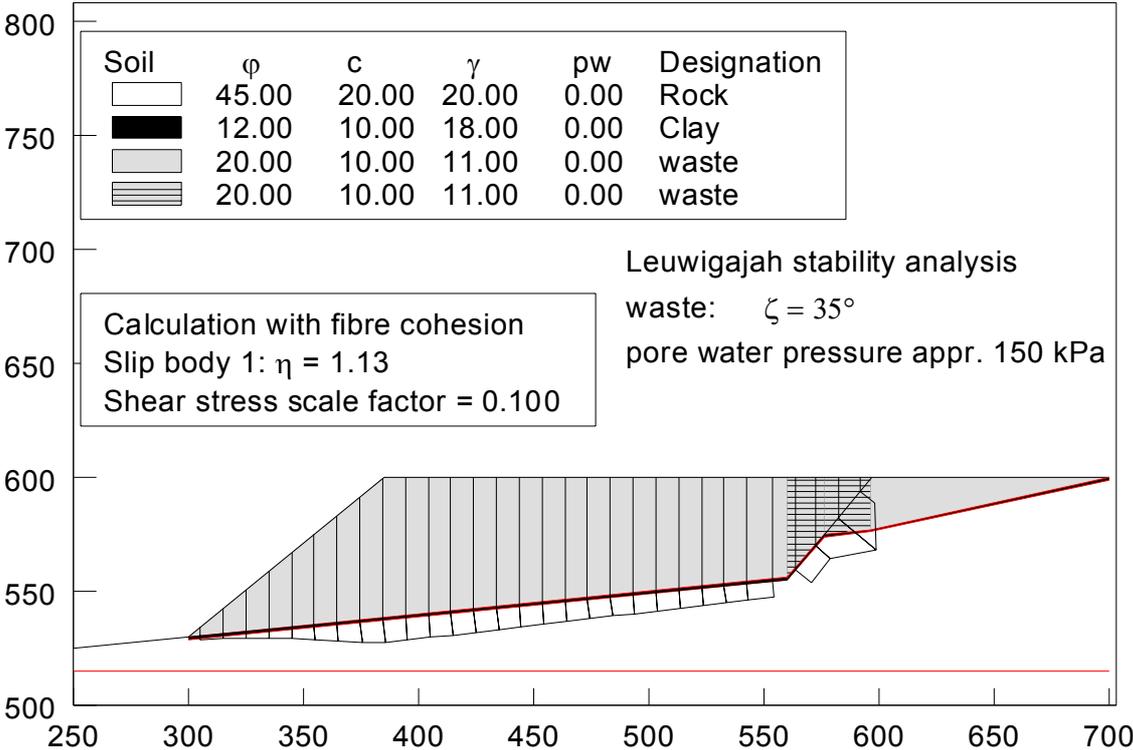
The results of the stability calculations for the Leuwigajah failure are displayed in figures 3 and 4. In Figure 3 a situation has been modelled without landfill fire. The overall stability amounts to $\eta = 1,13$. The impact of heavy rain has been considered by assuming a pore water pressure in the subsoil reducing the effective stress by approximately 150 kPa. The shape of the sliding figure corresponds with the situation found on site. Hundreds of alternative sliding figures have been calculated, particularly those forming shear planes through the waste. However, the most unfavourable one is that one shown in figure 3.

Figure 3: Stability analysis for Leuwigajah dumpsite – case: non burned waste

The shear resistance, which is drawn on the bottom of each slice, shows clearly the impact of the fire. The peak of shear resistance at slice 2 and 3 in the upper end of the sliding figure in figure 3 has disappeared in figure 4. Just the shear resistance due to friction is left. The smouldering fire had contributed significantly to the stability problems.

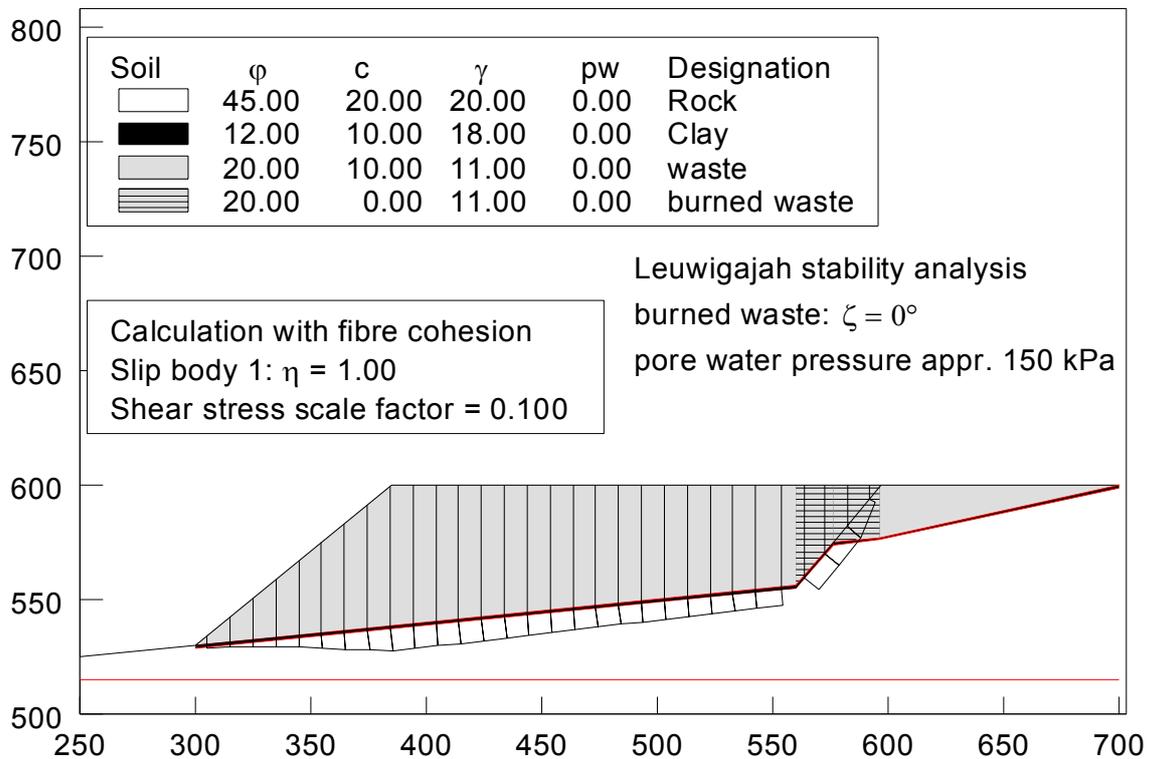
Figure 4: Stability analysis for Leuwigajah dumpsite – case: burned waste

Figure 4 shows the situation after the landfill fire had destroyed the reinforcement particles in the upper part of the landfill. It was assumed that all tension based components of shear resistance (tensile angle ζ and cohesion c) have been cut down to zero. Friction components were considered not to be concerned. Overall stability dropped down from 1,13 to 1,00, the dumpsite becomes instable. Again, the shape of sliding figures fit to the on site observations. No other figure with a smaller factor of safety has been found.

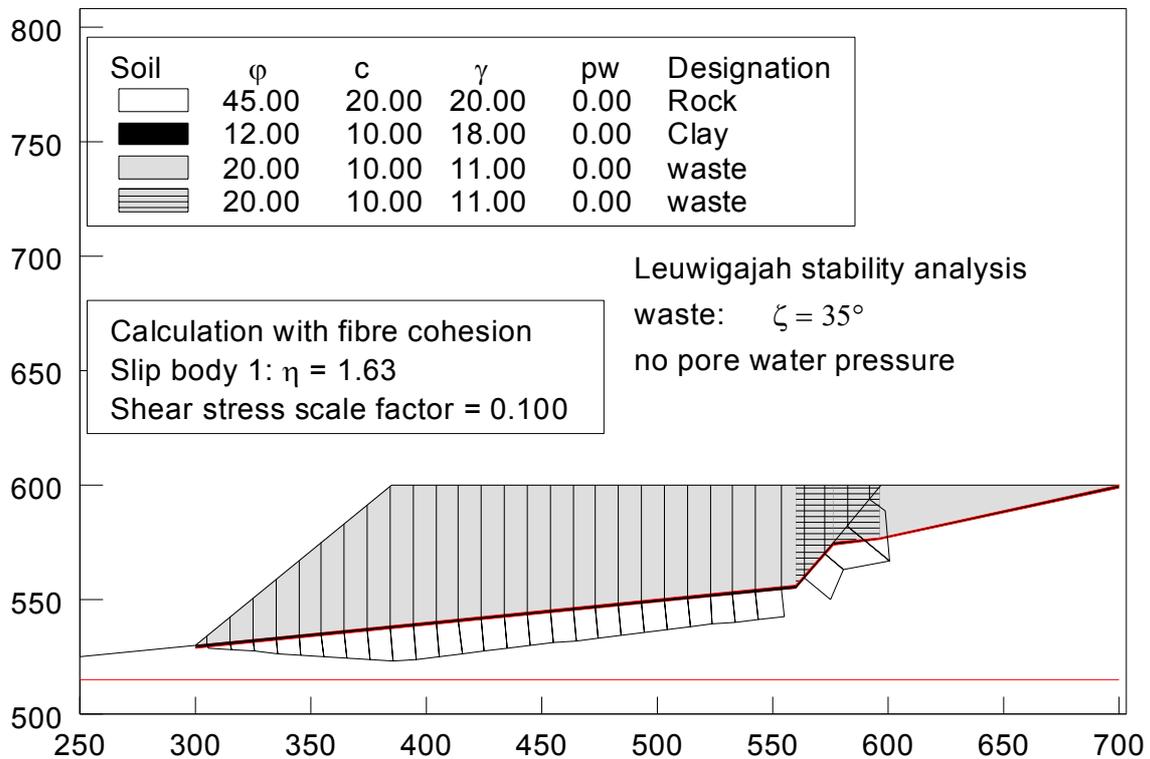
Regarding its impact, the water pressure inside the subsoil is more important. Provided a proper construction and a appropriate operation, the landfill would not have faced any stability problems at all. Figure 5 shows the situation, reflecting the case of proper drainage and no fire. Overall stability is $\eta = 1,63$. Therefore, stability problems could have been avoided by simple measures.

Figure 5: Stability analysis for Leuwigajah dumpsite – case: proper construction and operation

Regarding landfill construction it is necessary to ensure proper drainage. As the Leuwigajah case has shown, the strength of the waste is not the major problem, since strength capacity is more than sufficient. It is more important to take care for the soft sections of the landfill construction. Especially the soft soils need protection, no matter whether it is a natural deposit or a technical barrier.

Regarding the operation, the message is perfectly clear: landfill fires can not be accepted. Smoking mountains are well known in poor countries, but the risk of disasters is enormous. Landfill fires require immediate fire fighting actions, smoke and smell should be recognized as a serious sign of alert not as an ugly, but common attitude of landfill operations.
