Stability problems of landfills – The Payatas landslide

Dr.-Ing. Florian Koelsch

Dr. Koelsch Geoenvironmental Technology LLC

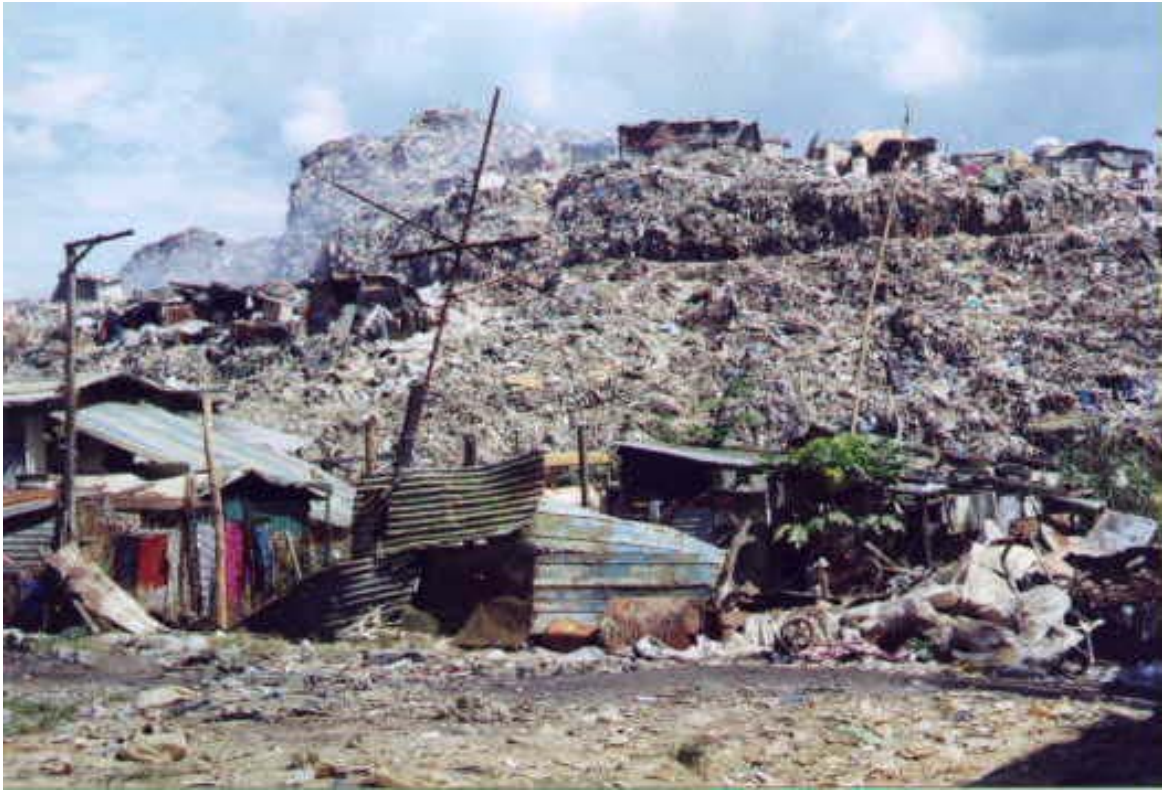
Figure 1: Housing situation at Payatas dumpsite before the landslide

The Payatas dumpsite is located in the North-East of Metro Manila within in the boundaries of Quezon City on Luzon, the major island of the Philippines. About 1000 t municipal solid waste per day are delivered to the site, some 15-20% of the total amount of municipal solid waste (MSW) generated in Metro Manila. Around the dumpsite, the City of Payatas houses 80.000 people, many of them working in waste business like in junk stores or as waste pickers (scavengers). The scavengers, who have the worst job in this micro-economy often have to live directly on the open waste surface of the dumpsite. Figure 1 illustrates the housing situation at the Payatas dumpsite before the landslide.

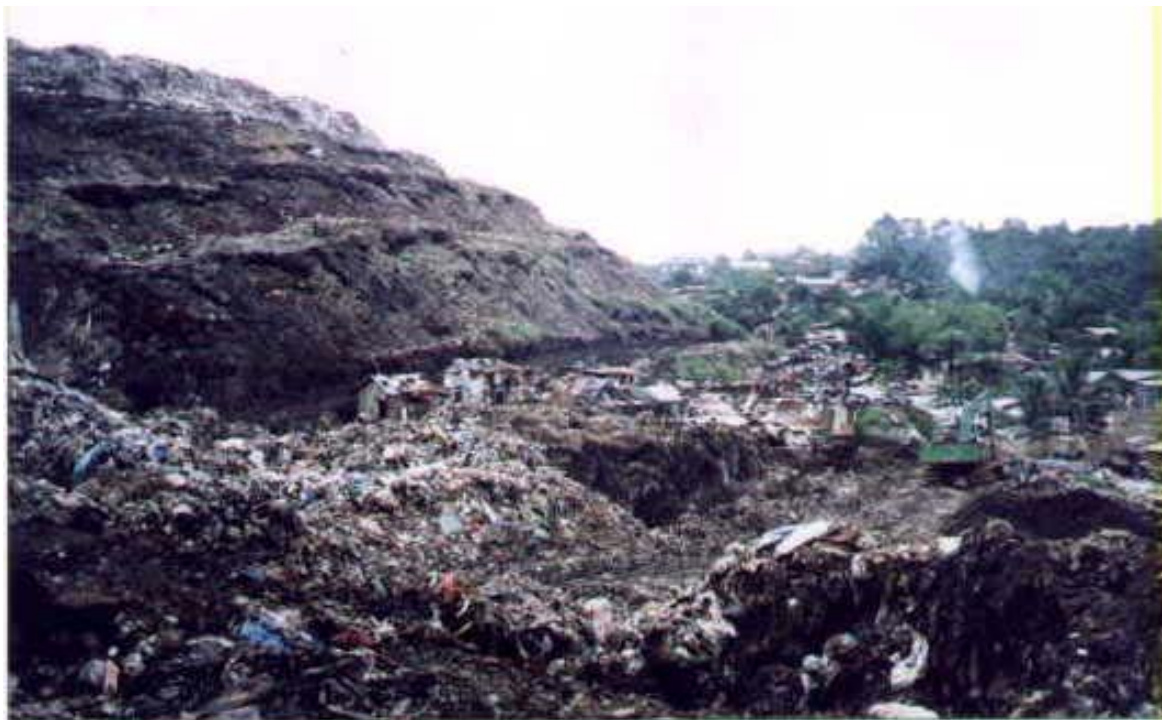
Figure 2: Collapsed slope at the day after the failure

On July 10th around 5 A.M., a slope of the landfill failed and 1.2 Mio m³ waste slid down burying both cottages of the scavengers and a part of Payatas B under 10 m of waste. In front of the toe of the slope an area of around 30.000 m² was completely covered by waste and debris. Figure 2 shows a part of this area at the day after the landslide in front of a remaining slope, where still huts of wastepickers can be seen. Rescue actions were hindered by landfill gas, which created several fires. More than 220 people were found dead in the plastered area. 4 weeks after the landslide, rescue works were suspended. There was no longer hope to find survivors, and even the dead bodies were heavily degraded, which made the identification impossible. Therefore, estimated 200 to 800 people are still missed. The area was leveled and secured by simple measures (peripheral trench, block lines)

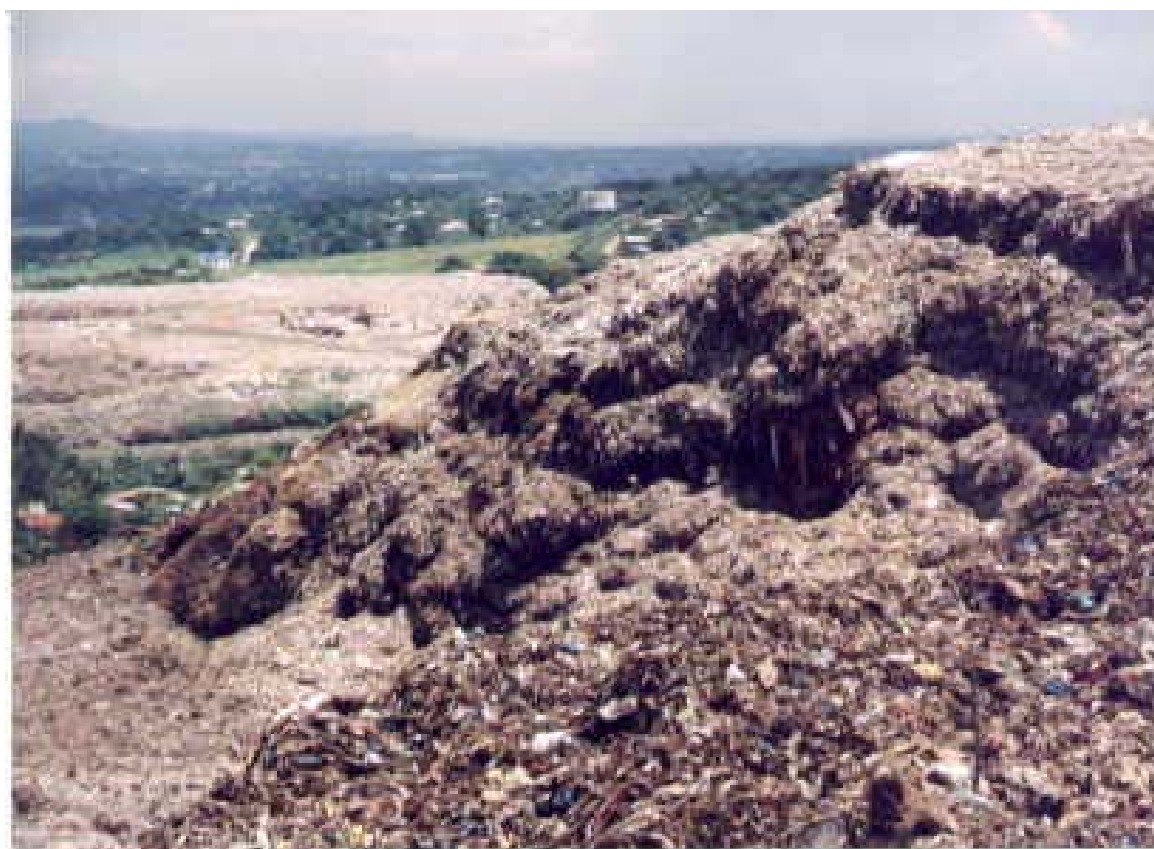
Figure 3: Broken slope at Payatas dumpsite – August 2000

Basically, a landslide happens in case a slope is constructed steeper than the shear strength of the material is sufficient to bear. Since the strength of waste is not well-known and is usually not being investigated in the laboratory, the waste is placed due to common experiences. It seems that the geometry of the Payatas dumpsite has met these experiences showing slopes of about 1:3 with a height of 25 m. However, some specific conditions, which show up in tropical developing countries, apparently have not been considered, thoroughly.

- **Low density of waste** due to a high portion of light plastic materials and an insufficient waste compaction
- **Unlimited water percolation**
The water percolation is usually adjusted by paper. The observation has shown a lack of paper due to an outstanding high recycling ratio
- **Extremely high rates and non-uniform distribution of rainfall**

The major reason for the landslide is the low waste density. The low density reduced the surface flow of rainfall water and resulted in a high rate of water infiltration into the waste. The leachate water decreased the shear strength by mobilizing pore water pressure and triggered finally the failure. Waste settlements, which come along with a high content of organic materials, were driving this effect. The major reason for the low waste density was due to the composition of waste delivered to the Payatas dumpsite. The composition was characterized by a high portion of plastics and organics and an absence of certain other materials (paper, glass, metals). MSW composed in this matter is reluctant to conventional compaction methods, even by using heavy equipment. The waste composition in Manila is typically for urban areas in developing and emerging economy countries. Basically, it results from an extraordinary consumption of plastics as package material, a lack of recycling systems for organic waste and an outstanding recycling rate for reuseable materials. The high recycling rate primarily reflects the poverty of the country, which enforces people to earn their living by segregating waste at dumpsites. The impact of the low density on the landfill stability was amplified by heavy rainfalls which are characteristic for the tropical location.

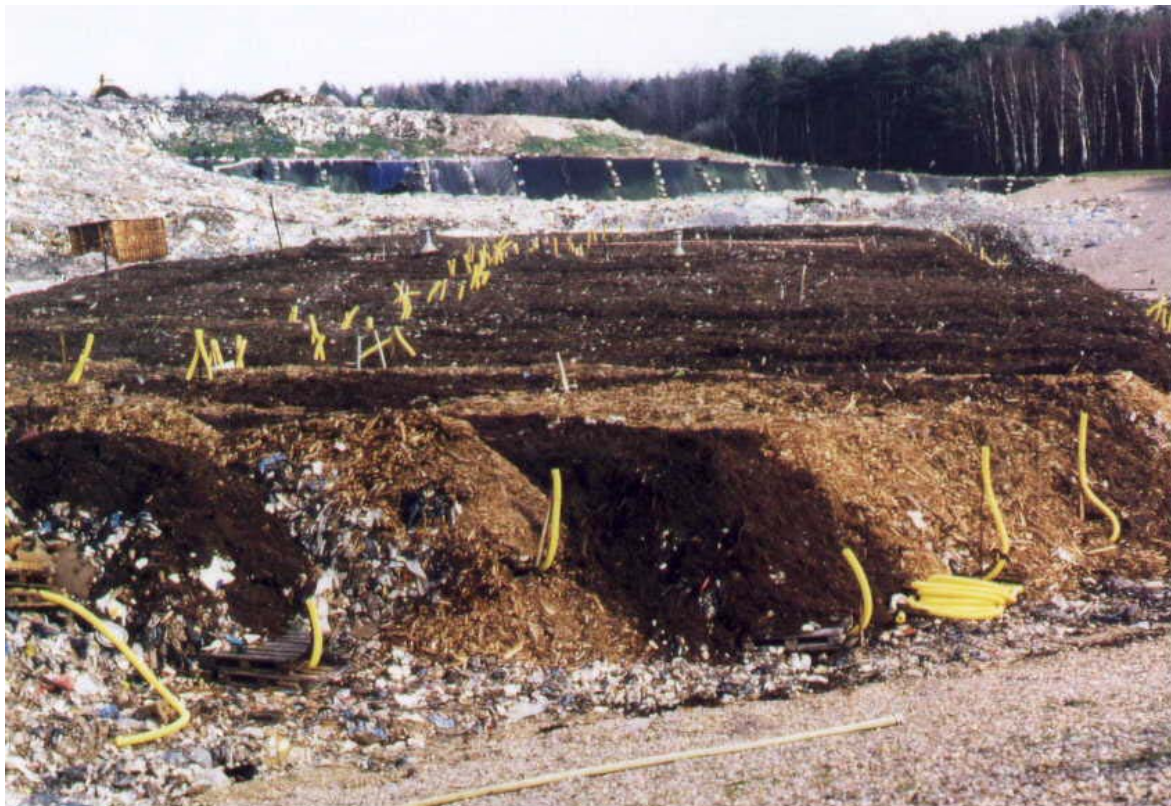
Biological pretreatment is the technical keystone to improve stability. For the Payatas dumpsite, a simple treatment plant has been proposed. The plant should operate by the chimney-effect system like shown in figure 5 (Koelsch, Reynolds, 1999).

Figure 5: Chimney-effect system at Meisenheim landfill (Germany)

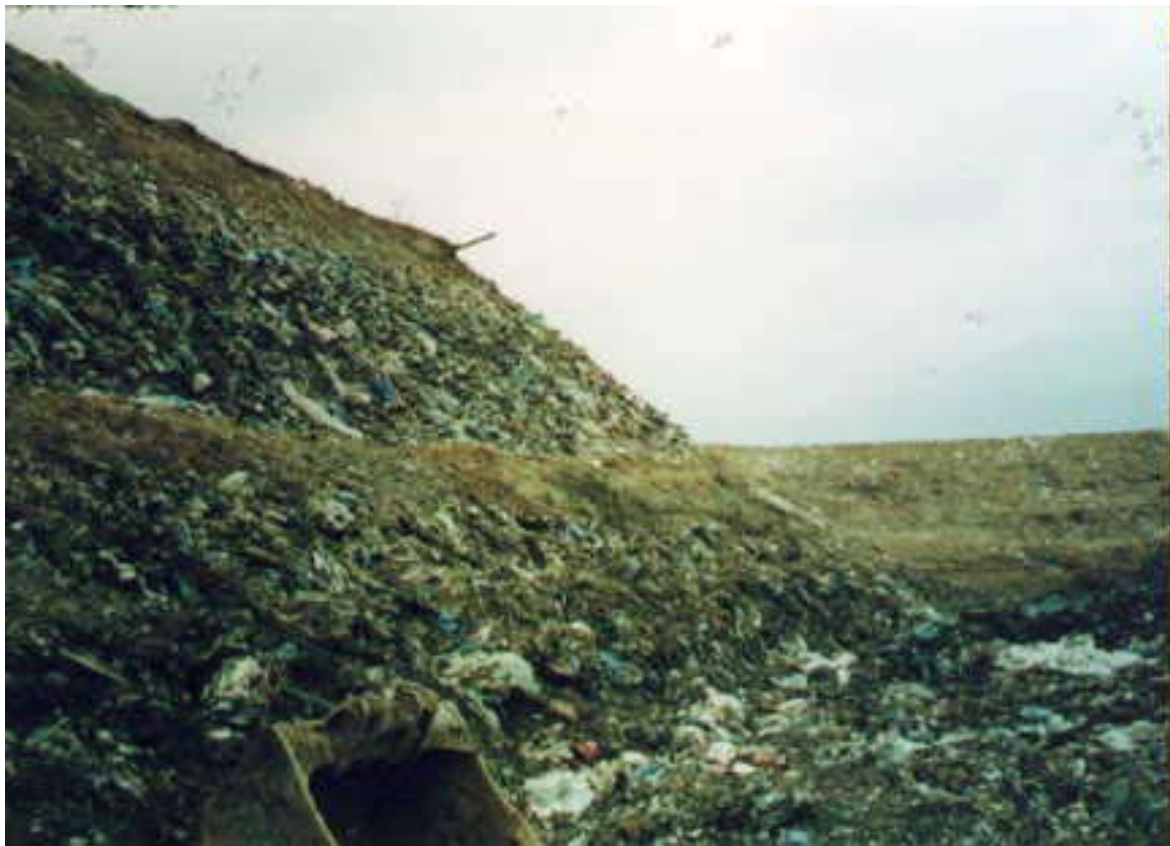
Figure 6:Landfill mining at Goettingen Deiderode – steep slope

However, considering the reinforcement effect requires special calculation methods, but finally the described procedure will deliver a realistic evaluation for the slope stability. Additionally, an appropriate stability analysis may enable to make use of the waste strength in order to build steep temporary slopes or to expand the maximum landfill height – provided the landfill is in a good geotechnical shape. Both utilizations can be helpful in mining or construction situations. Figure 6 shows a 75° steep and 25 m high slope, which has been constructed at the Goettingen landfill in Deiderode (Germany) during the mining of the „grandfathered“ landfill area. The slope was even calculated and designed for an slope angle of 90°. Unlike the original plan, the slope has been held open for almost 3 years without showing any stability or deformation problems.
